NASA CR - 132731  
(SER - 50944)

**STUDY TO INVESTIGATE DESIGN,  
FABRICATION AND TEST OF LOW COST CONCEPTS  
FOR LARGE HYBRID COMPOSITE  
HELICOPTER FUSELAGE - PHASE I**

Sikorsky Aircraft

June 1975

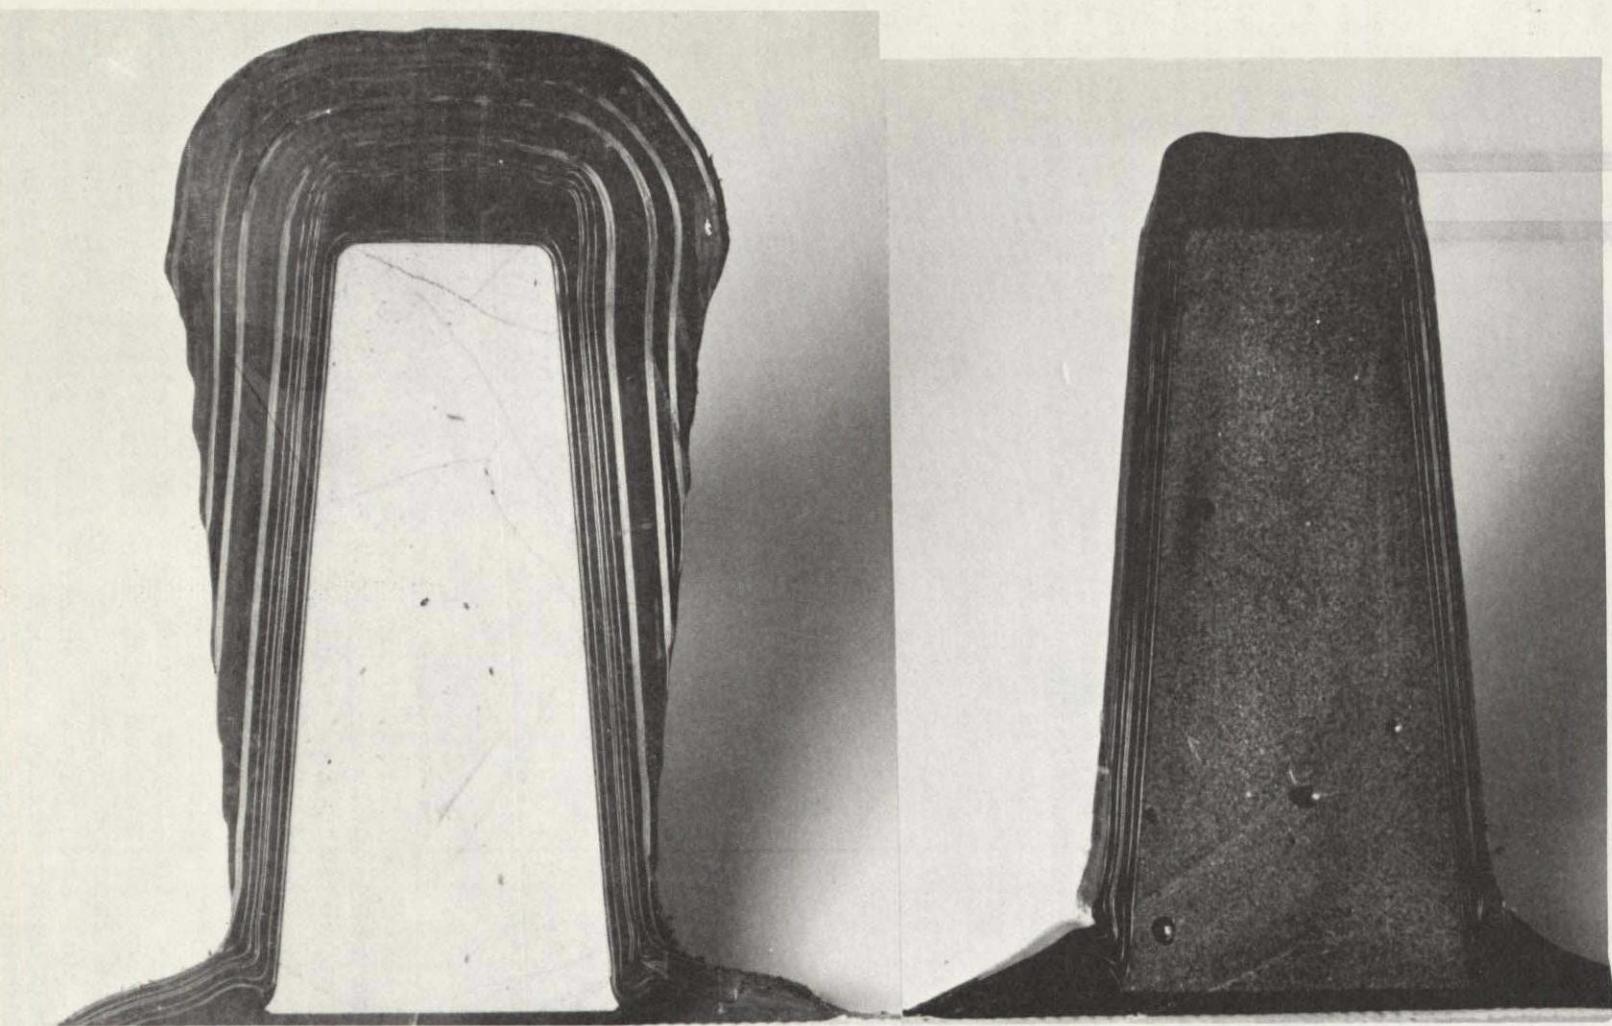
FIGURE 28b. CROSS SECTION VIEW OF FRAME LAMINATE EWR-39411-042 SPECIMEN #2 SHOWING WEB LAMINATE BULGES AT BASE OF FOAM.

were fabricated using the original silicone contour bag for cold compaction and debulking. When the bag was removed, each of the specimens had developed the bulges at the base of the frame laminate, proving the assumption that the bulges were caused by failure of the bag to provide pressure in that area. The bulge was removed when each of the specimens was rebagged with a conventional nylon film bag before cure.

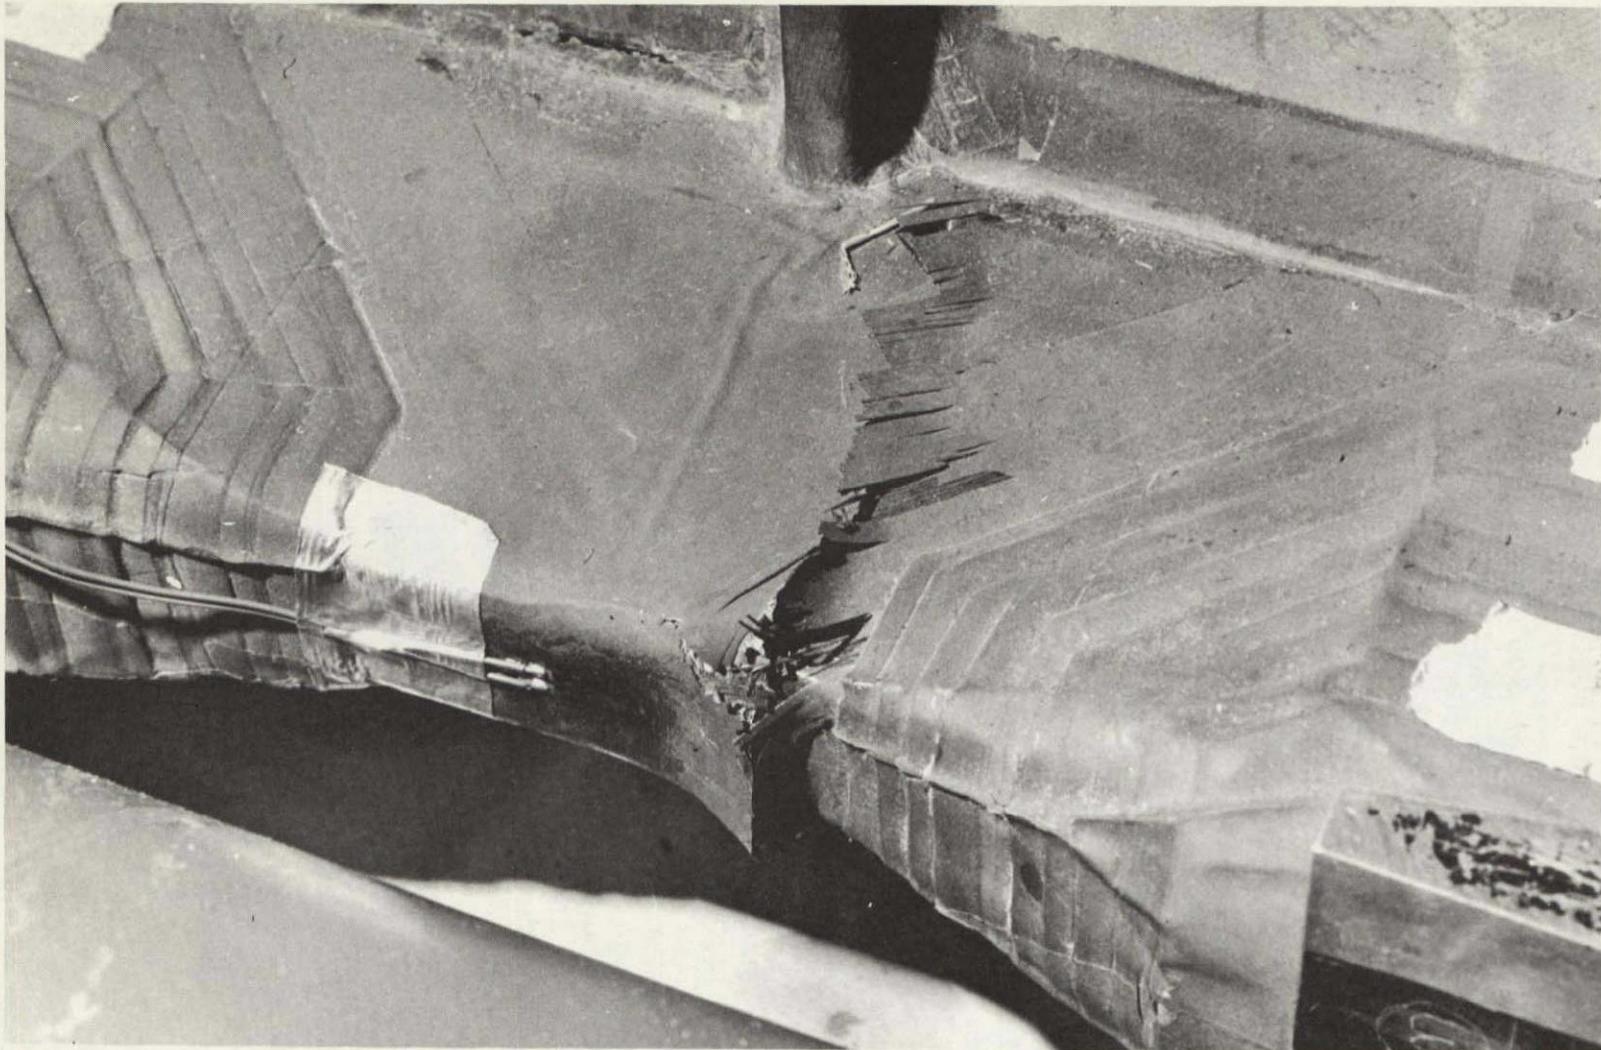
an audible indication of failure was heard at approximately 53.4 kN (12,000 lb) load 5000  $\mu$ inch/inch strain. The final load at fracture was 76.0 kN (17,000 lb) axial, with a bending moment of 11.98 kN·m (106,900 in lb). Both frame bending specimens failed in compression at the upper frame cap (away from the skin surface), see Figures 33 and 34 and when sectioned, both specimens revealed similar fractures as shown in Figure 35.

FIGURE 33. FRAME BENDING SPECIMEN #1 SHOWING FRACTURE IN UPPER CAP,  
EXTENDING THROUGH WEB TO LOWER CAP.

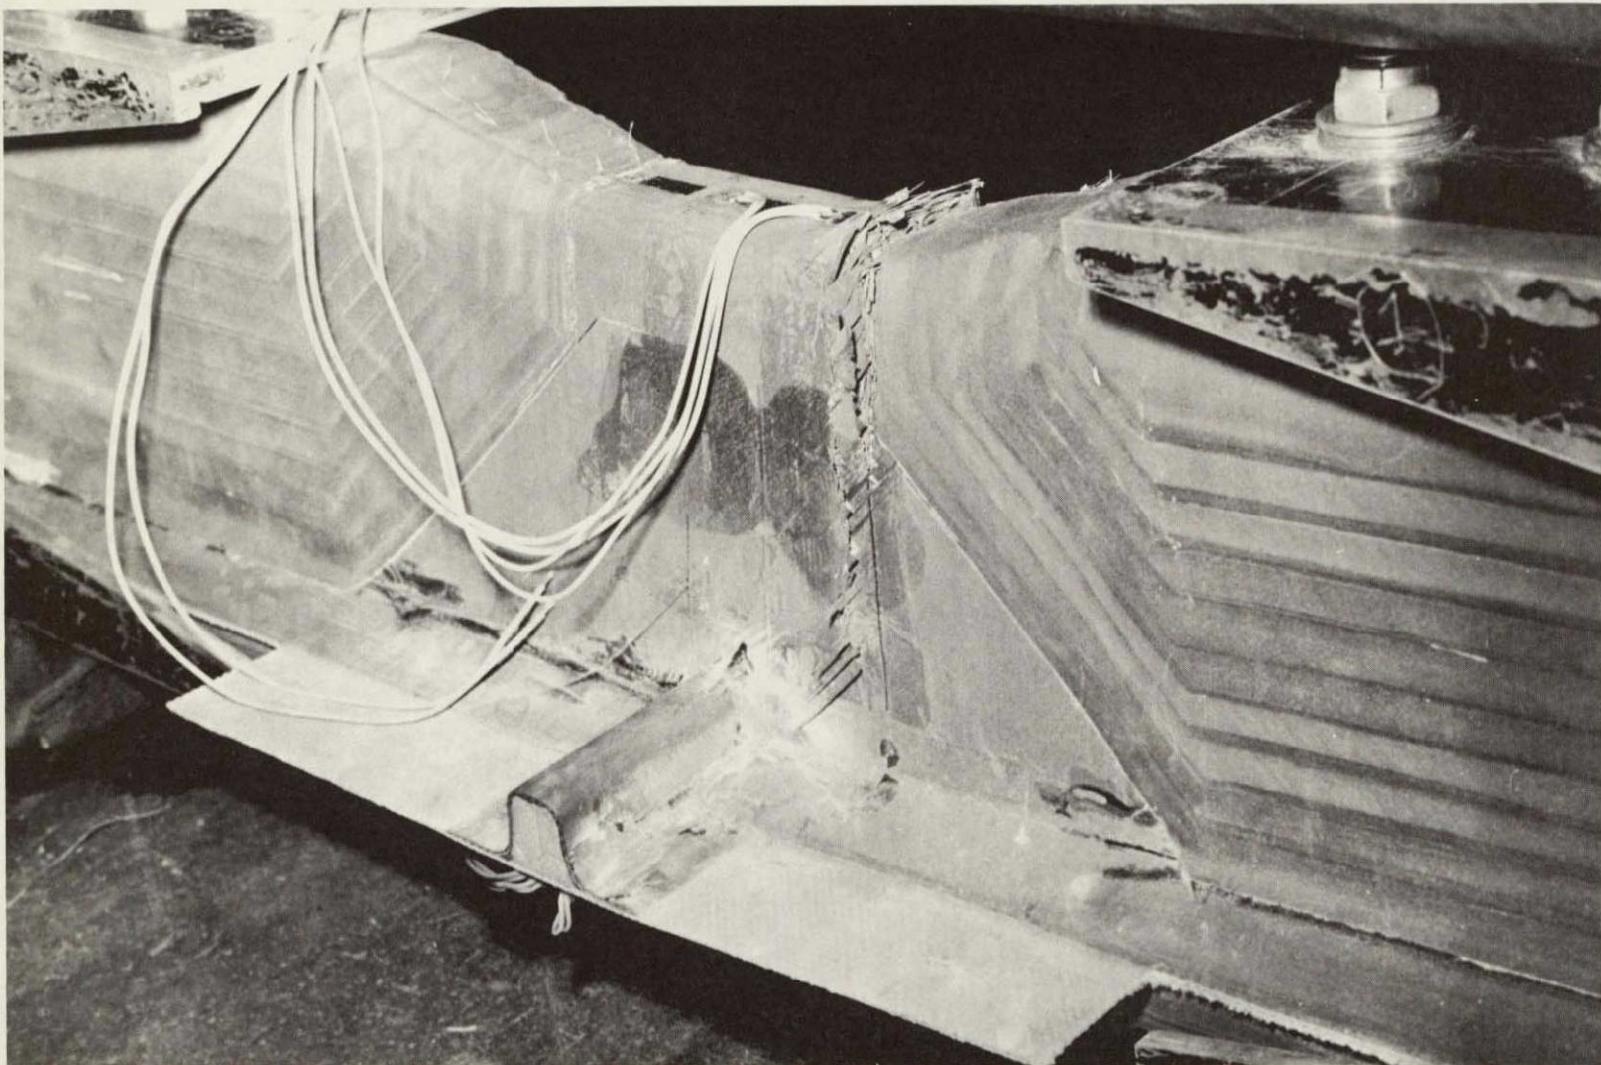
FIGURE 34. FRAME BENDING SPECIMEN #2 SHOWING FRACTURE IN UPPER CAP,  
EXTENDING THROUGH WEB TO LOWER CAP.

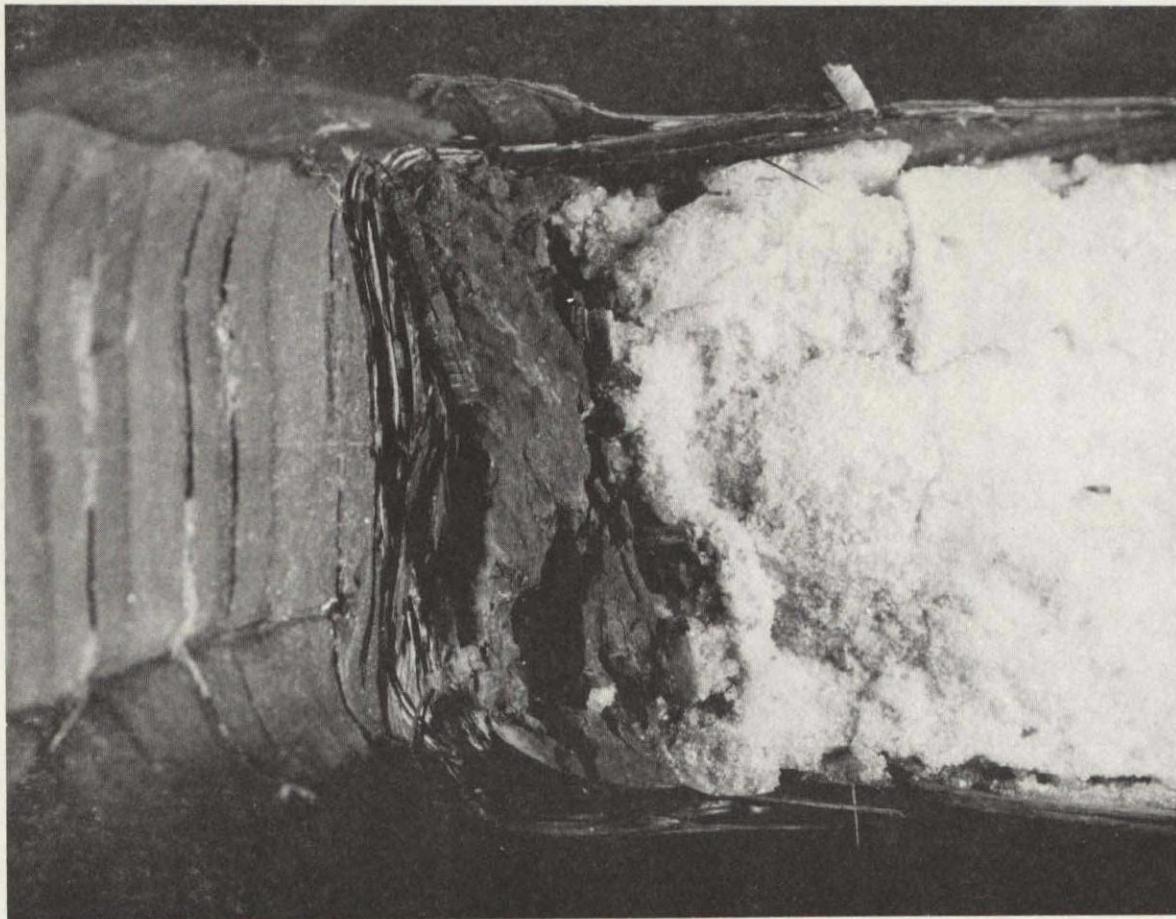
FIGURE 35. FRAME BENDING SPECIMEN #1, SECTIONED AT PLANE OF FRACTURE TO REVEAL COMPRESSION BUCKLING OF  $0^\circ$  GRAPHITE CAP LAMINATE.

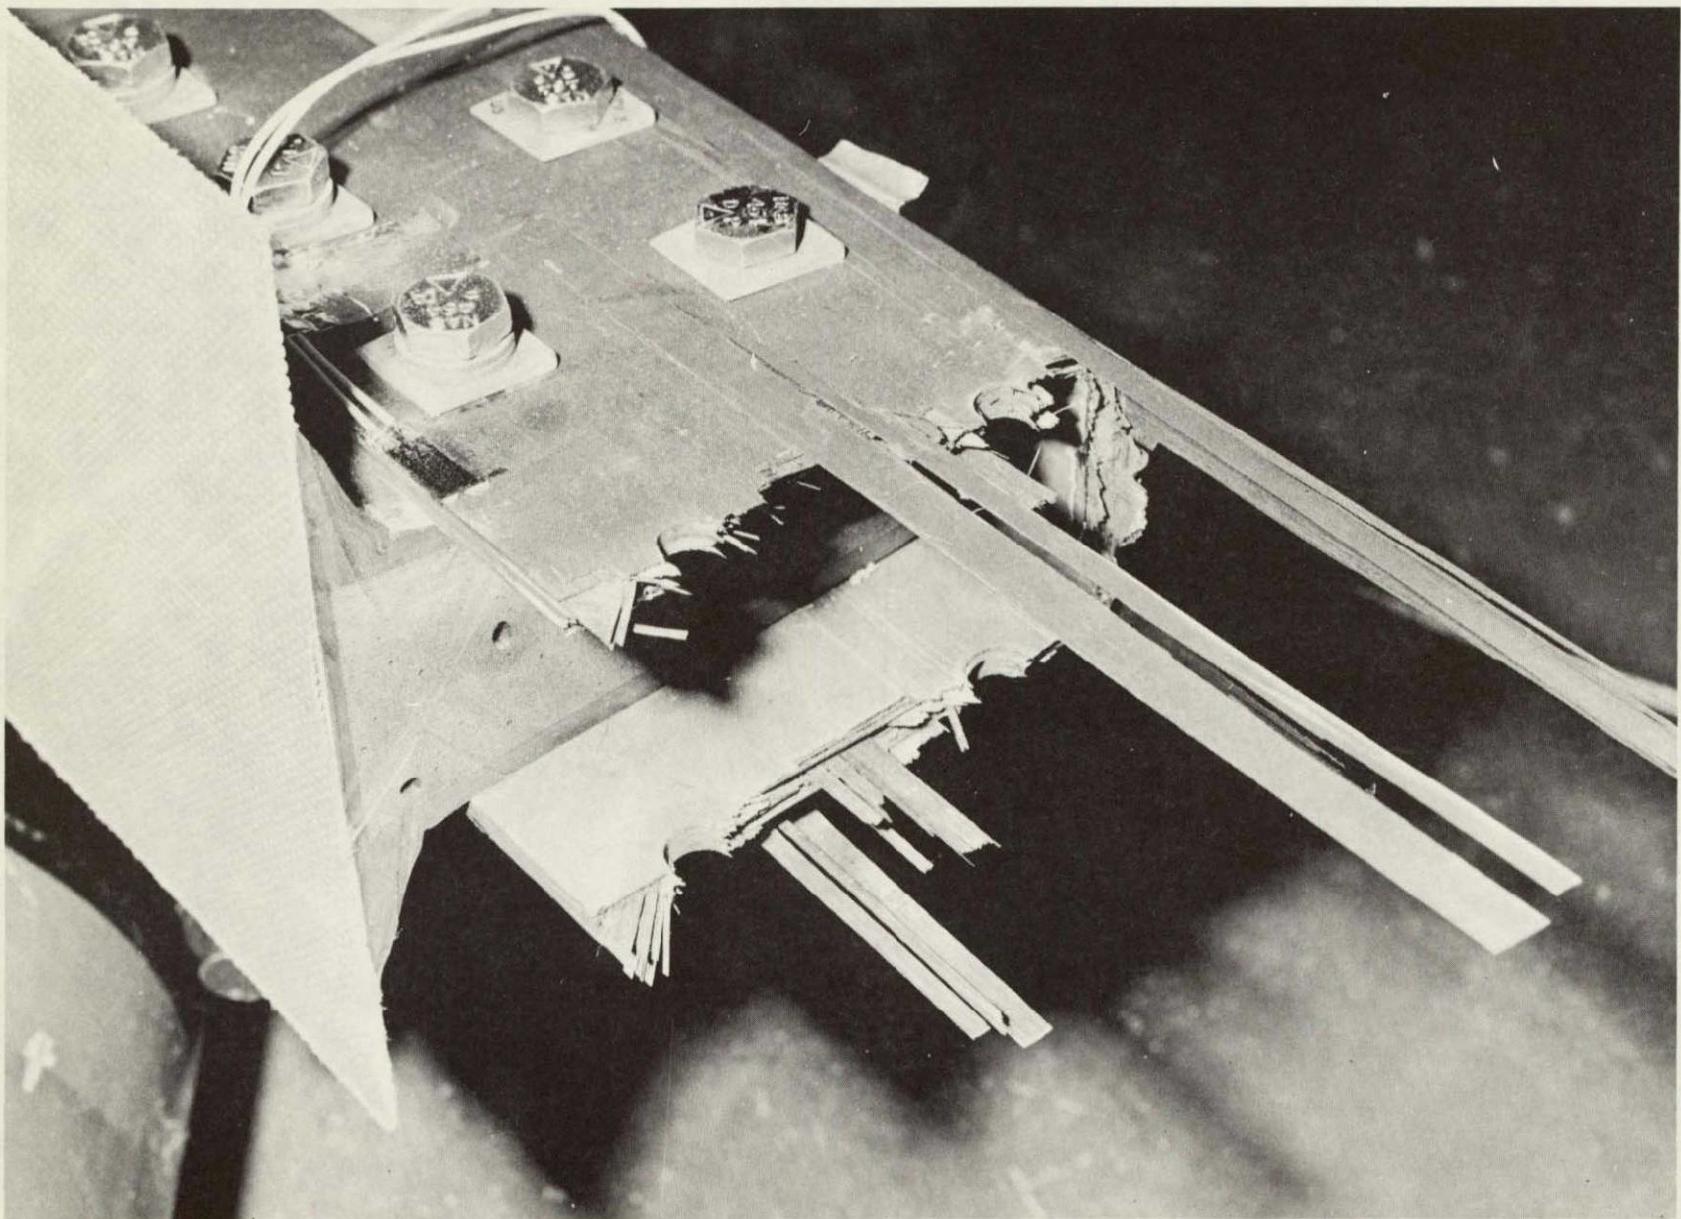
Both frame splice specimens were loaded to fracture. As shown in Figure 32 the load was applied similarly to the frame bending specimens. Specimen number one fractured at a compressive load of 33.8 kN (7,600 lb) and a bending moment of 5.2 kJ (46,000 in lb). Specimen number two failed at a compressive load of 37.7 kN (8470 lb) and a bending moment of 6.0 kN·m (52,900 in-lb). The strain at failure was 6300  $\mu$  inches/inch for both specimens. As shown in Figures 36 and 37 both specimens fractured identically at the point of maximum stress, in the test fixture. Both fractures originated at or adjacent to the lower bolt hole. As experienced in the testing of the frame bending specimens, numerous audible indications of damage were apparent until fracture.

FIGURE 36. FRAME SPLICE BENDING SPECIMEN #1 SHOWING FRACTURE OF FRAME SPLICE CAP AT ATTACHMENT HOLES.

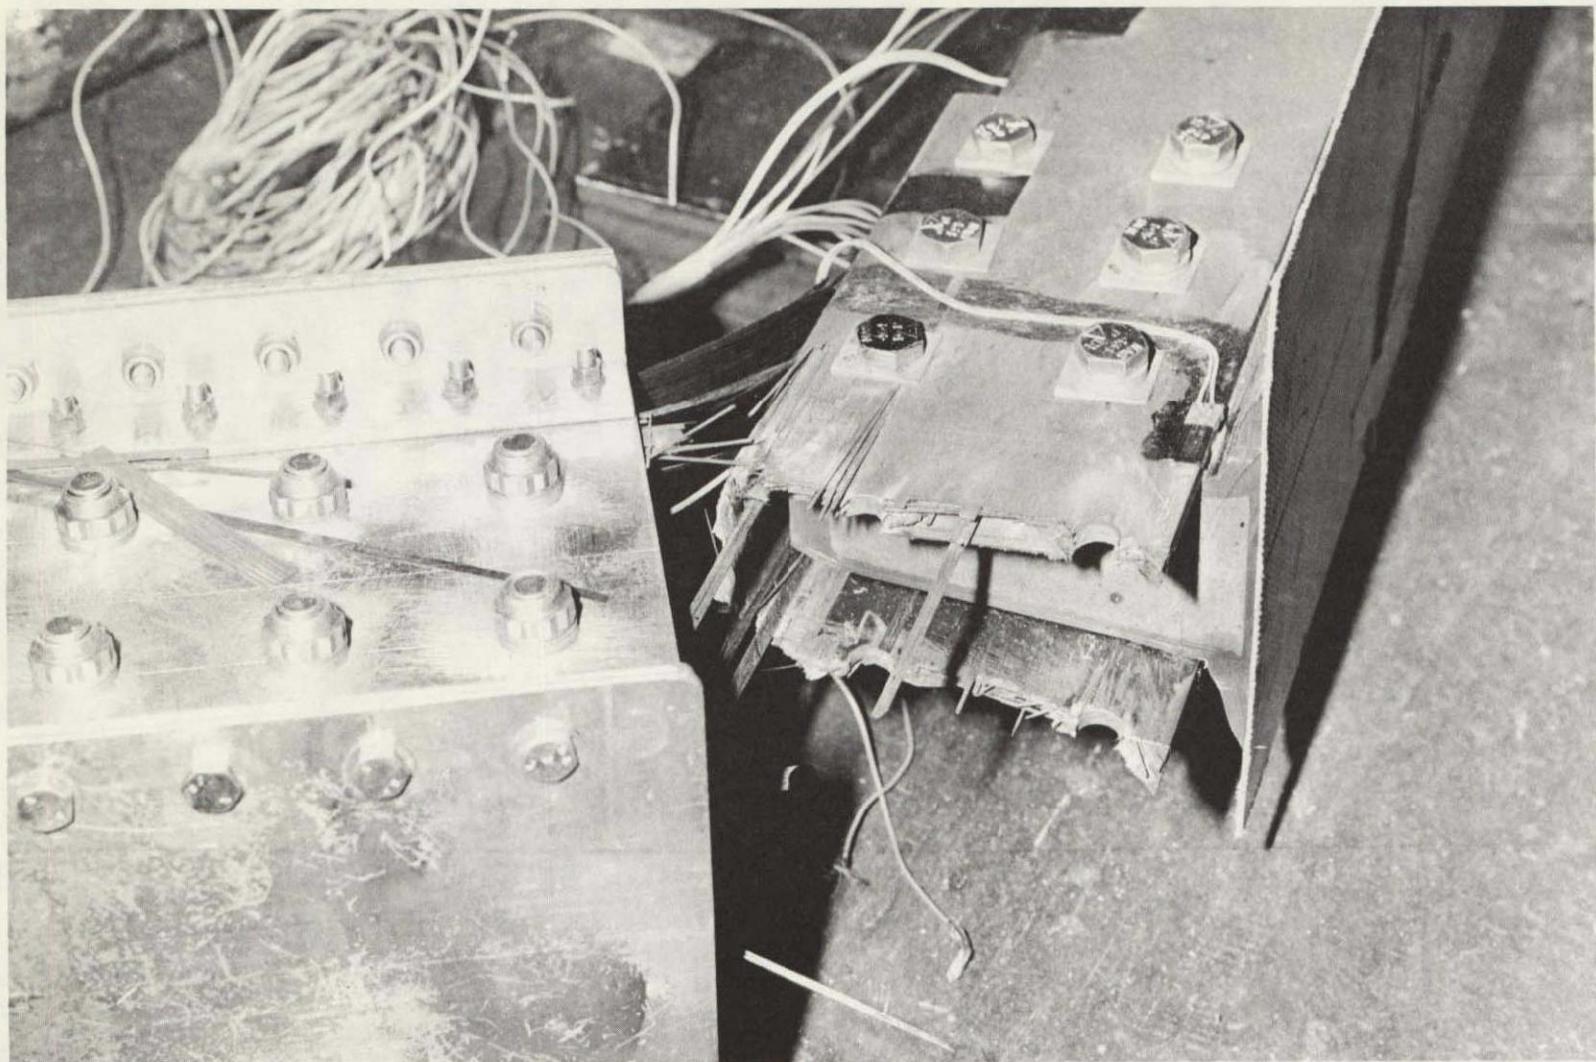
FIGURE 37. FRAME SPLICE BENDING SPECIMEN #2 SHOWING FRACTURE AT TEST FIXTURE ATTACHMENT HOLES.

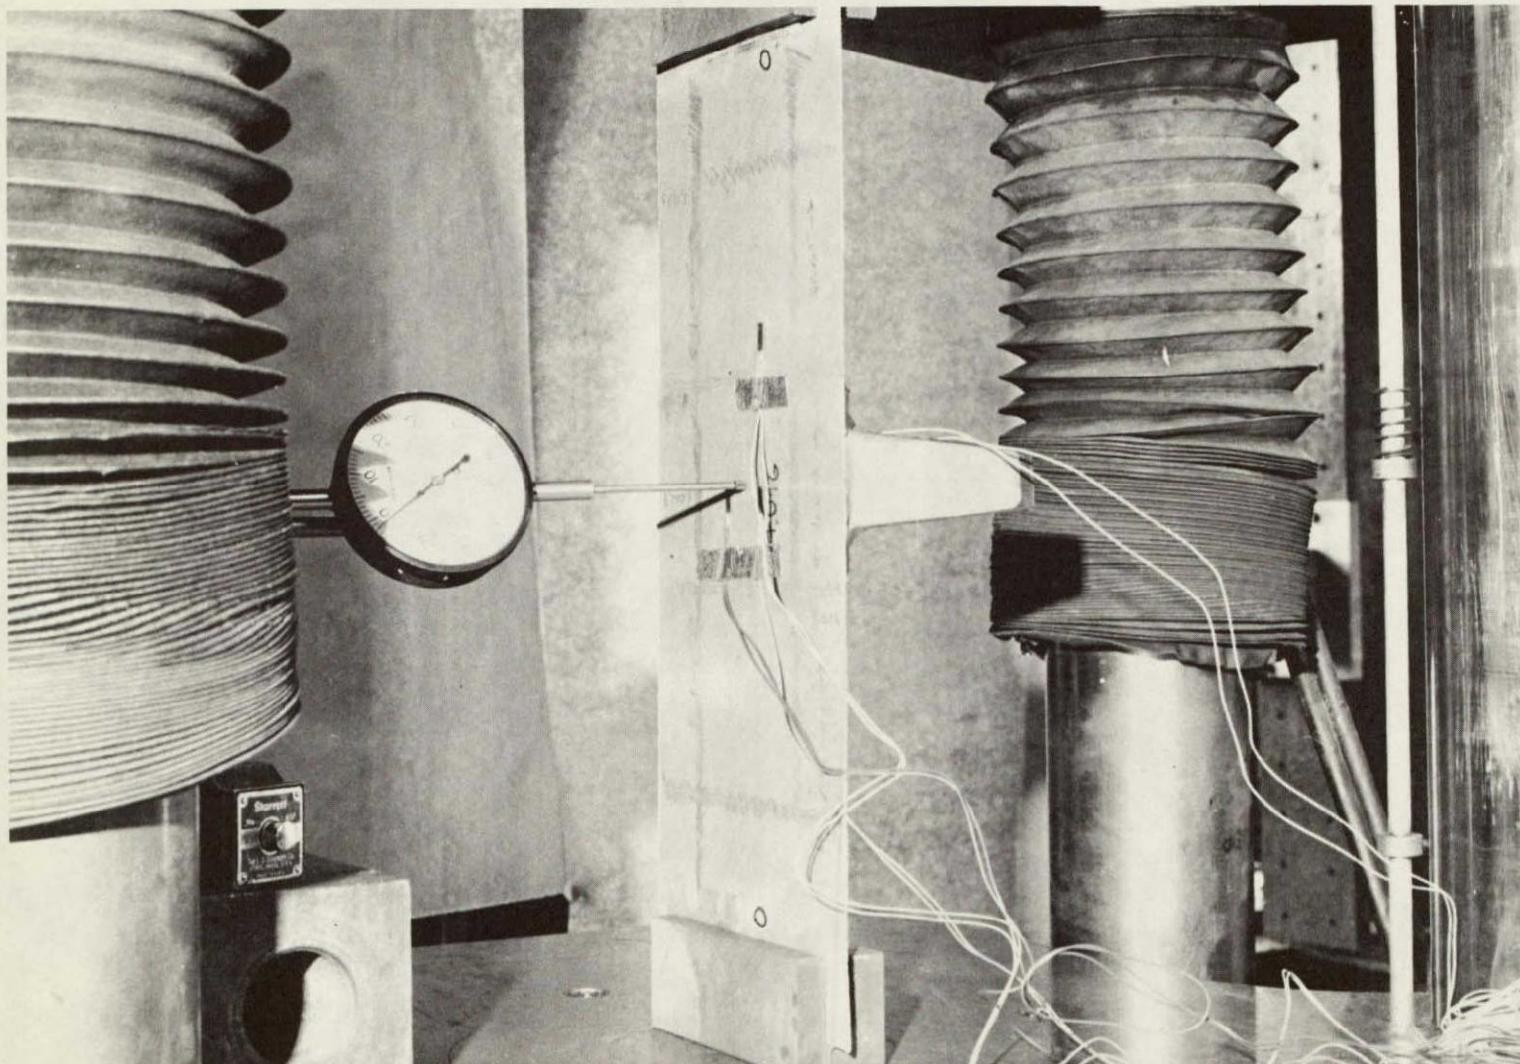
FIGURE 38. STRINGER TEST SPECIMEN IN BALDWIN UNIVERSAL STATIC TEST MACHINE

The stringer specimens were loaded in compression as shown in Figure 38. Fracture occurred at loads of 29.8 kN (6700 lb) and 28.4 kN (6400 lb). Initial failure occurred when the skin laminate separated from the stringer flange laminate. As evidenced in Figure 39a for specimen number one and Figure 39b for specimen number two separation of the skin to stringer flange occurred at the intersection of the densified attachment area and the foam stringer core material. The concentrated load in this area caused the skin delamination. With the loss of the skin due to delamination the stringer laminate fractured in pure compression. The potted ends stabilized the specimens in the test machine and prevented any buckling failure.

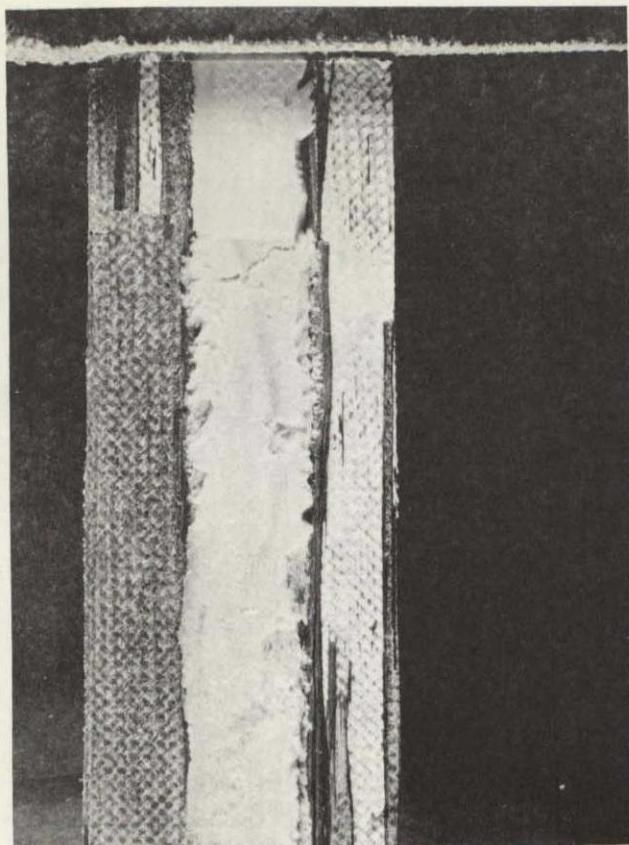
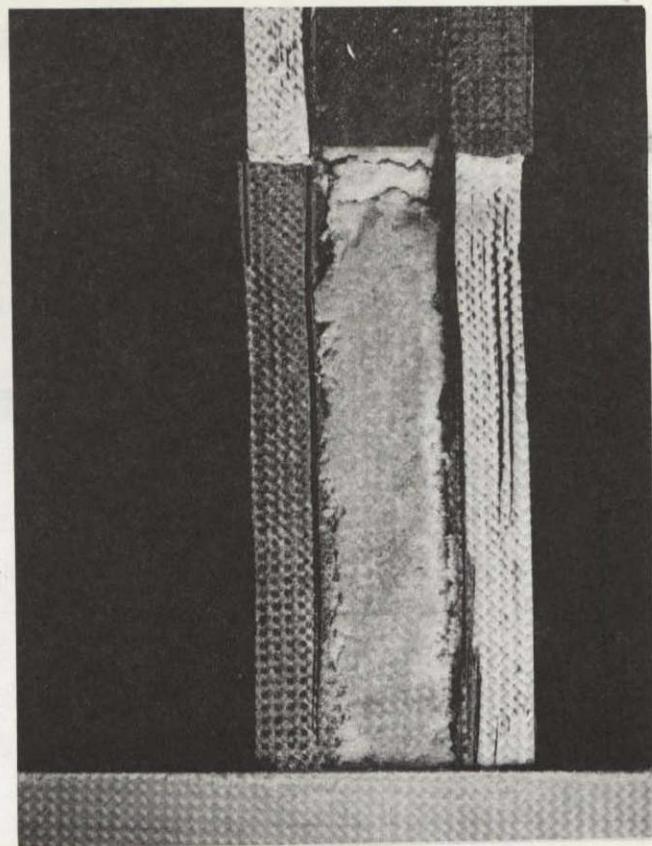
FIGURE 39. INITIAL FAILURE OF STRINGER TEST SPECIMEN OCCURED WHEN SKIN LAMINATE SEPARATED FROM STRINGER FLANGE LAMINATE.

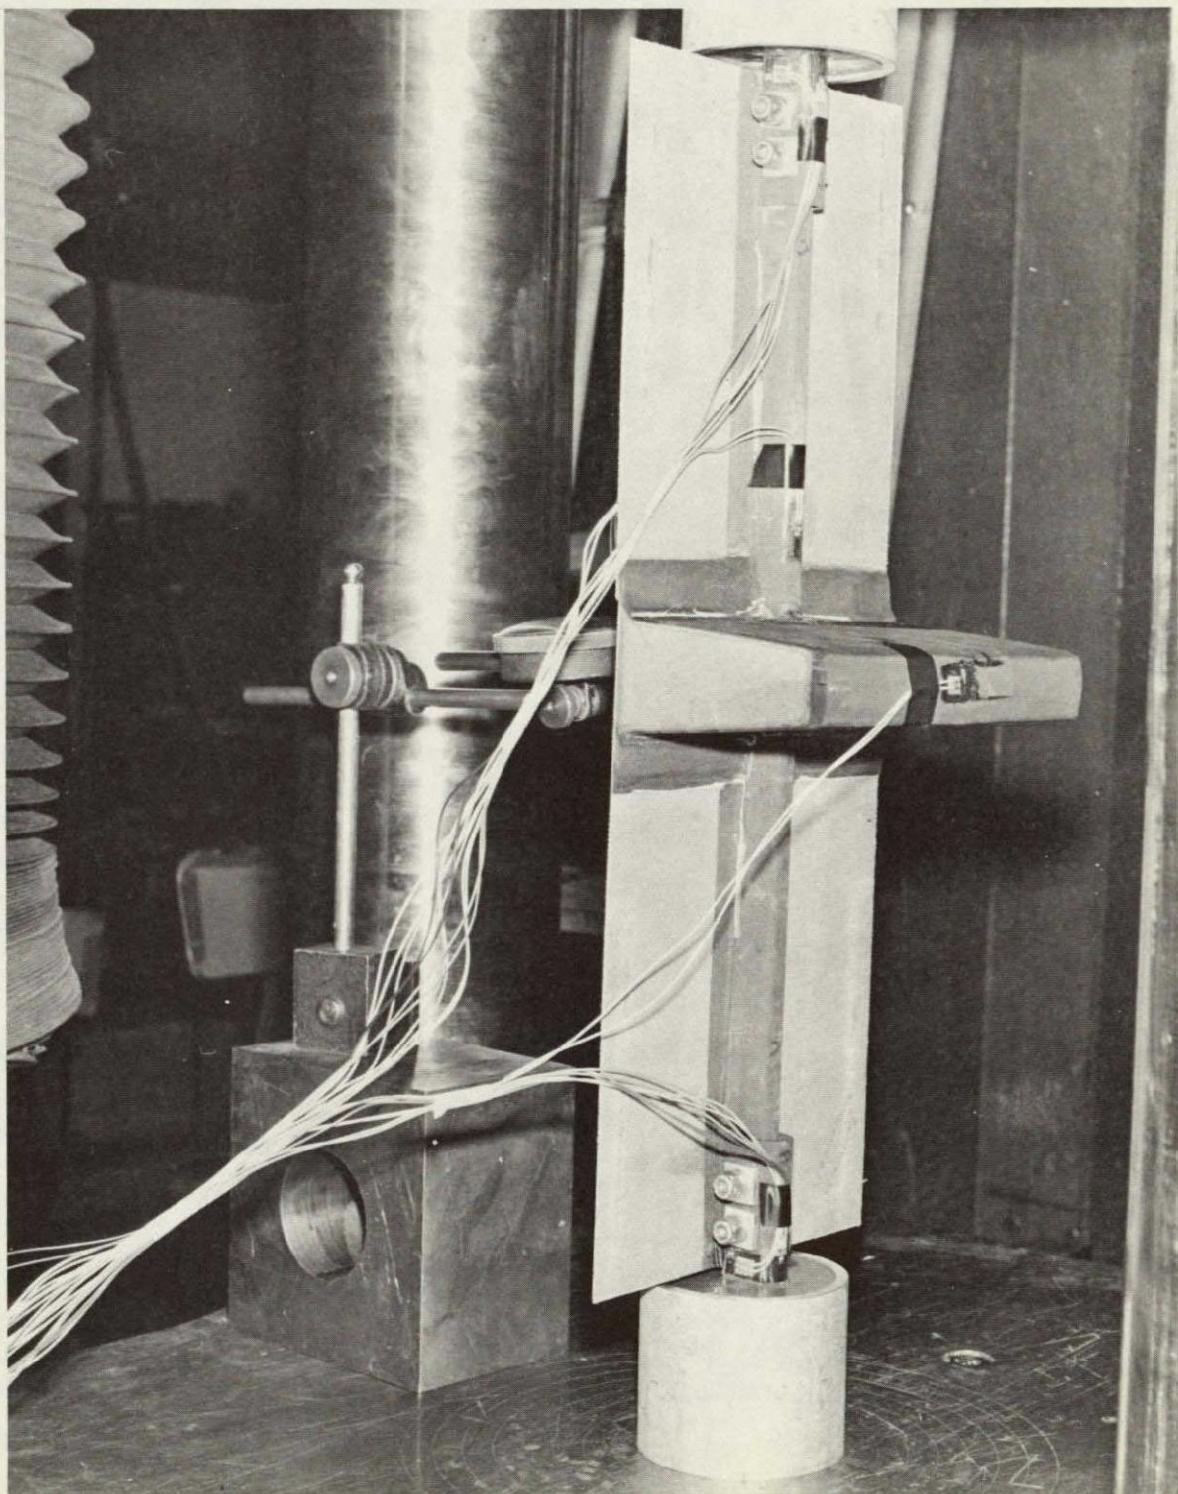
FIGURE 40. STRINGER SPLICE JOINT TEST SPECIMEN IN BALOWIN UNIVERSAL STATIC TEST MACHINE

The stringer splice specimens were loaded in compression as shown in Figure 40. Specimen number one failed at 15.5 kN (3500 lb). The strain at fracture was 6300  $\mu$  inches/inch.

Failure originated in the material between the bolt attachment holes and then continued to the machined edge of the splice cap. See Figure 41a. At no time during the load application was there any indication of failure, visual or audible. Although testing was discontinued at the inception of the original failure to prevent possible conflicting multiple

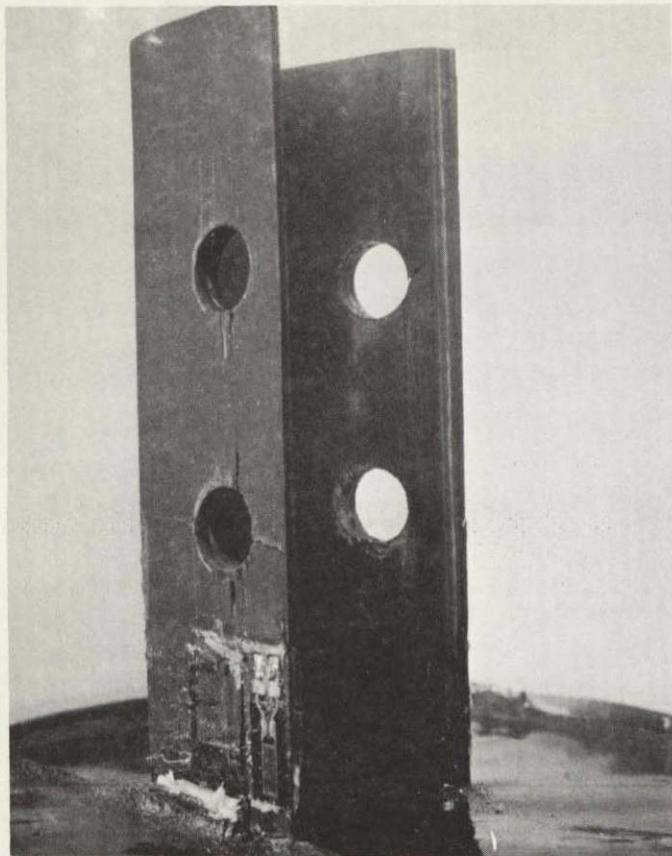
(a) SPECIMEN #1

FIGURE 41. STRINGER SPLICE JOINT CAP FAILURES.

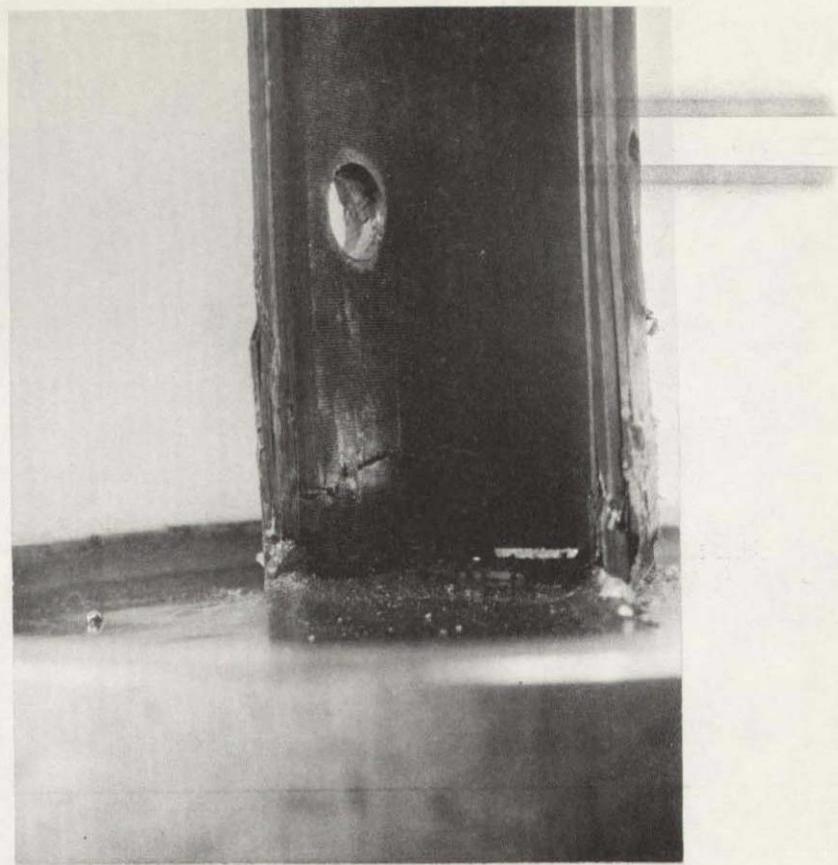
(b) SPECIMEN #2

damage modes, the splice joint was capable of sustaining continued load at a lower level. The second specimen failed at 14.68 kN (3300 lb). The strain at fracture was  $9200 \mu$  inches/inch. Fracture of the splice cap occurred adjacent to the potting compound as shown in Figure 41b and is a complete compression fracture of the splice cap laminate as evidenced by a brooming type failure of the fibers extending from one edge of the splice cap laminate to the other.
